Construction of Soil Conservation Structures for improvement of crops and soil productivity in the Southern Ethiopia

Abay Ayalew

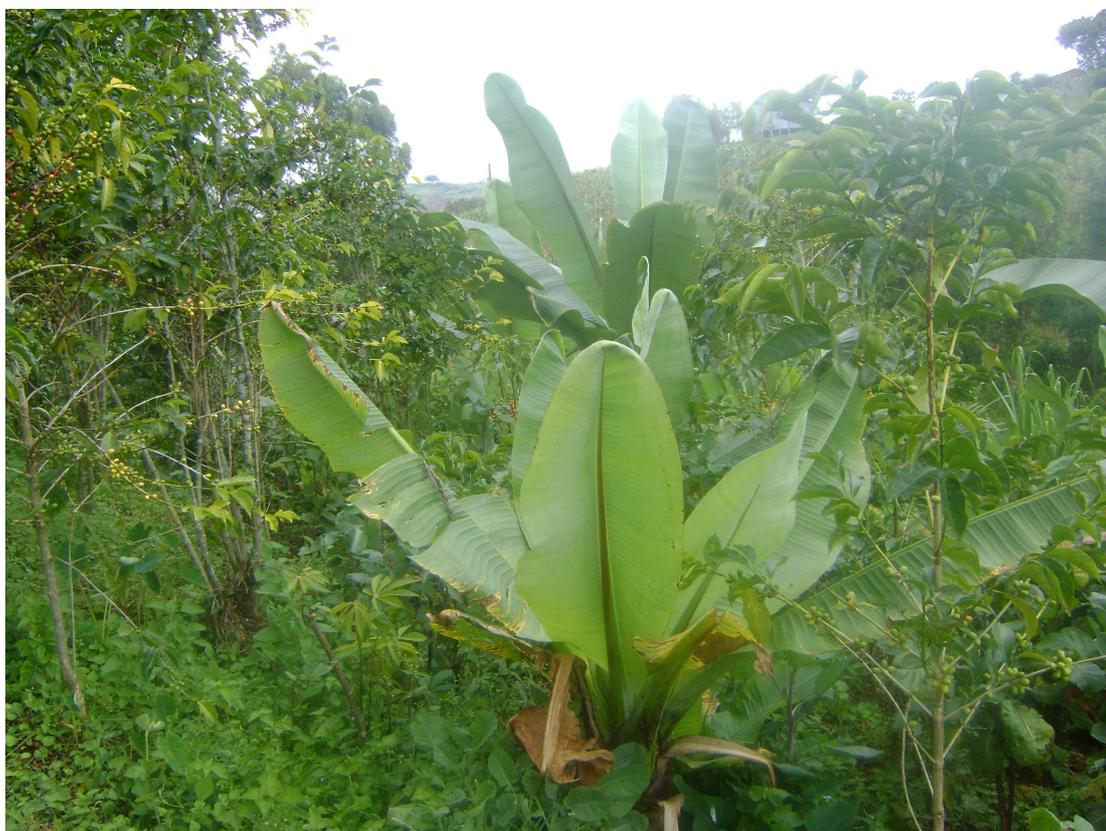
Fig 1. Perennial crops completely covered the soil at the homestead of Gununo farm

Having the problems, the farmers in the area continued cultivating the lands without trying to combat the soil erosion problem. Since the homestead areas are planted with perennial crops (Fig 1) like enset (false banana), banana, coffee, yam, taro and sweet potato, they are not affected by soil erosion as these plants cover the soil enough to reduce the detachment power of rain drops. The problem is on the outer field where cereals are mostly practiced. These parts of the farms are steeper than the homesteads and very much affected by erosion. Most of the farmers in the area perceived that erosion washes away the top fertile soil, seeds sown and applied fertilizers to down slope. But none of the farmers could control the erosion. Rather they preferred either to continue cultivating on the eroded and none protected land or leaving to other area because they could not

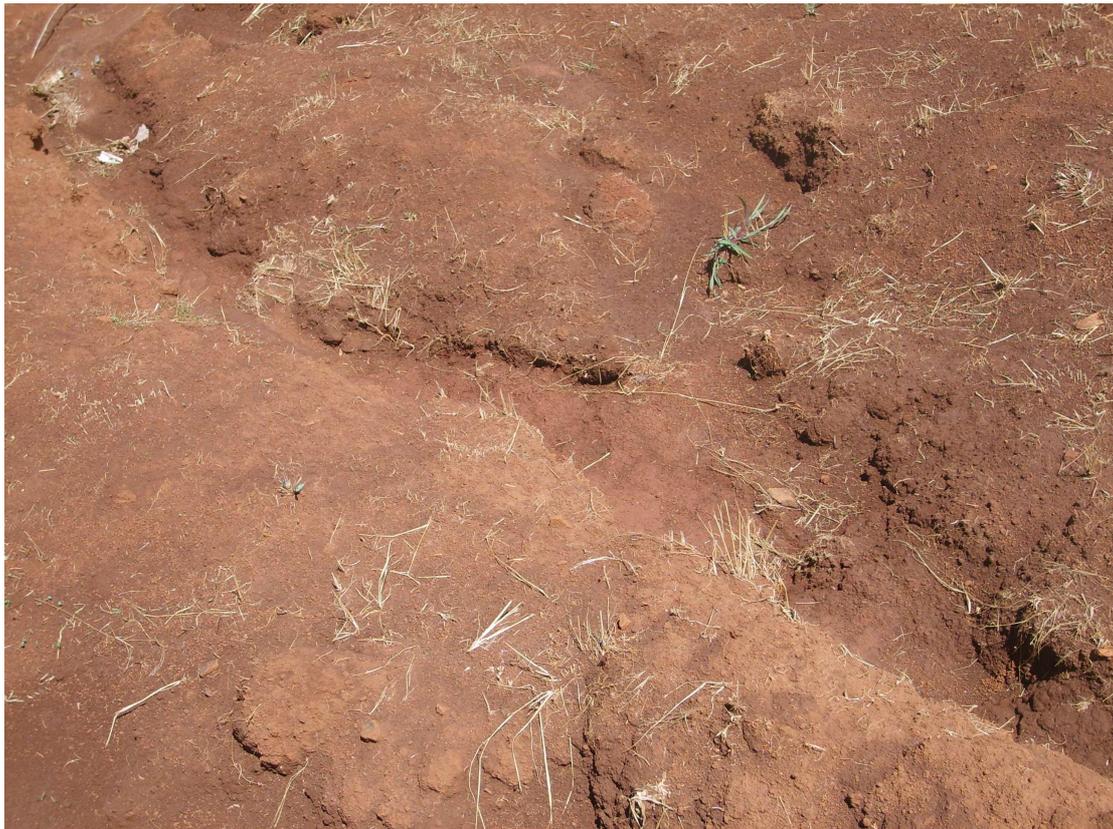
Fig 2. Eroded farm at Gununo before the introduction of soil conservation measures

Looking at this problem and not getting a solution some of the farmers in the area decided to leave their farms and be engaged in off farm activities until research intervention was introduced in to the area. Soil erosion removes top soil (Fig.1), which is the richest layer of soil in both organic matter and nutrient value. Implementing soil and water conservation measures that restrict runoff and erosion minimizes nutrient losses and sustains soil productivity (Bierman and Rosen, 2005). Soil fertility improvement on sloppy lands without soil conservation is unlikely as both mineral fertilizers and organic matter applied can be lost with erosion. Therefore, this study was initiated with the objective of conserving soils by constructing soil conservation measures.

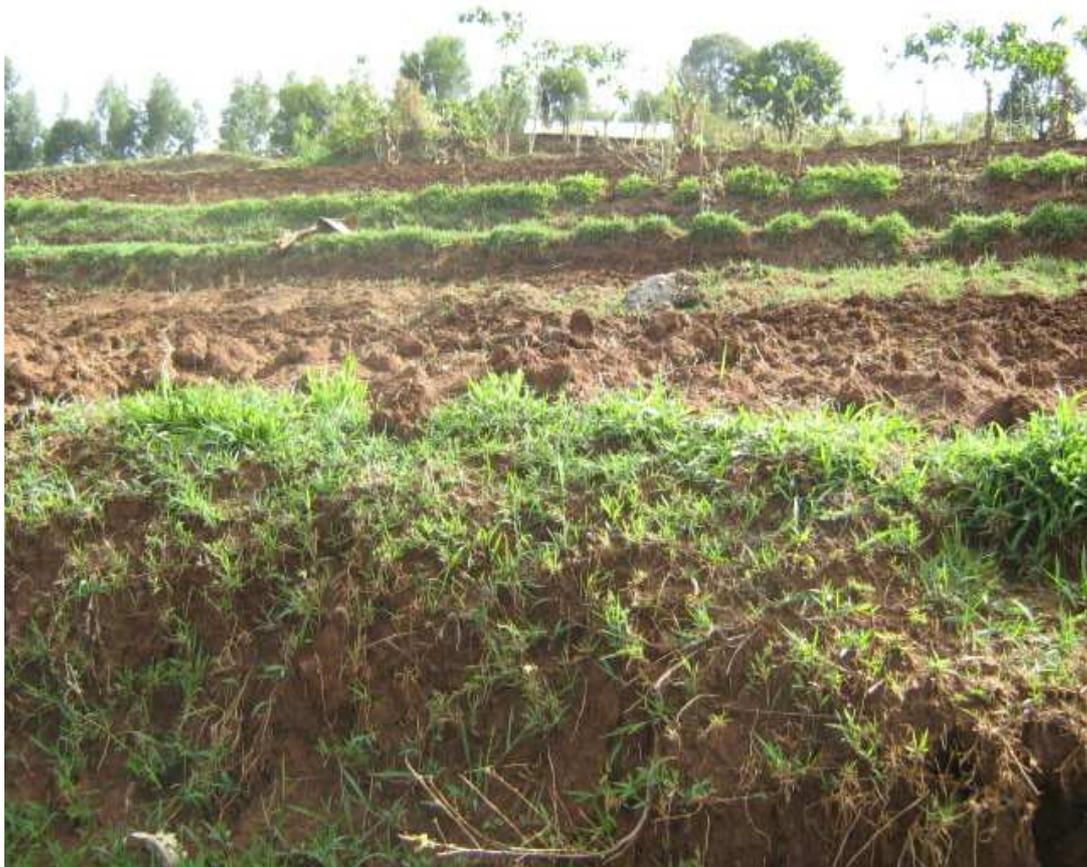
Fig 3. Elephant grass planted on newly constructed soil conservation structure

Forage plants such as Elephant grass and *Sesbania sesban* were planted on the soil conservation structures as stabilizers of the structures. The soil bund stabilizing grass reduced soil losses, improved the availability of organic inputs for soil improvement, and offered animal feed and consequent increase in cash income (Tilahun Amede, 2003). These forage plants are fast growing and the farmers harvested frequently and fed their cattle. The farmers who have these forages at their homestead could not suffer from the shortage of feed as those who had not planted. The plant species also greatly contributed to the stabilization of the soil conservation structure. *Sesbania seban*, legume plant species, besides being used as bund stabilizers and feed, it was chopped and incorporated in to the soil for improvement of soil fertility.

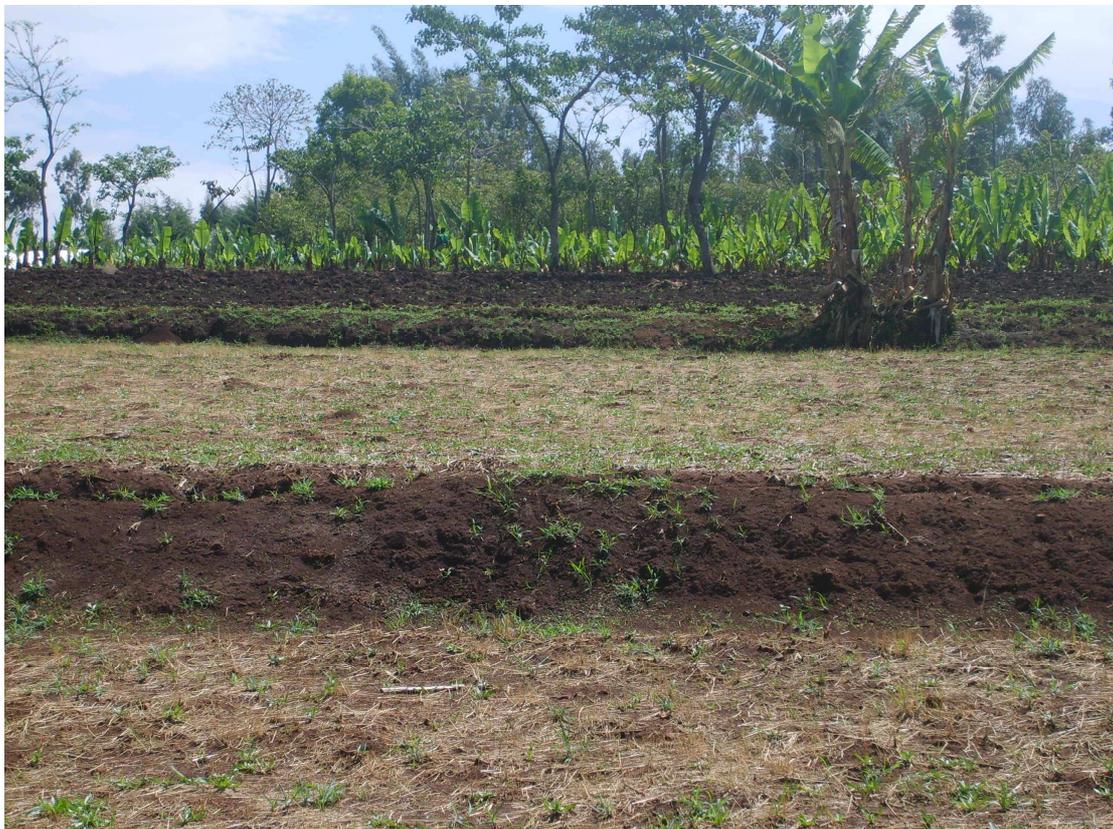
Fig 4. Well conserved farm in Gununo area

Mr. Temesgen said that he prefers the soil conservation technology to all the other technologies introduced to the area. The farmers in the area very well perceived that the soil conservation measure protects the washing away of soil, seeds and fertilizer and thereby increases crop yield. There is no any sign of soil erosion observed on the field, the soil is built up, it became dark, retained moisture well due the construction of the soil conservation measur(Fig 4).
